THE 1987 COALBED METHANE SYMPOSIUM

8752 Characterization of Fracture Geometry and Roof Penetrations Associated with Stimulation Treatments in Coalbeds

W.P. Diamond (U.S. Bureau of Mines, Ground and Methane Control Group)

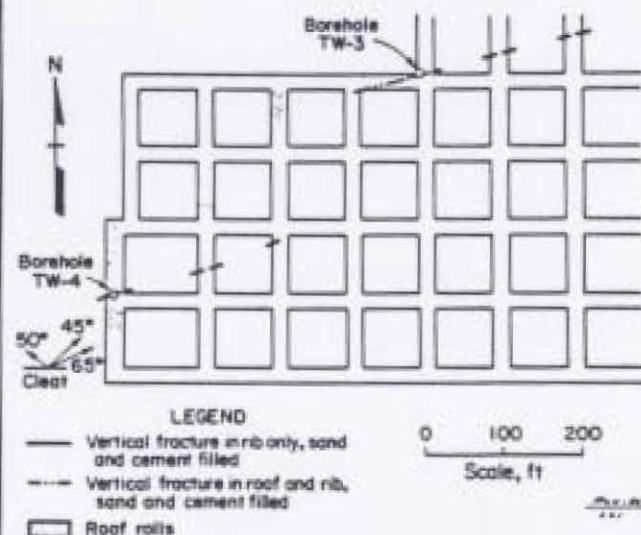
Vertical sand-filled fractures were generally wider nearest the borehole and narrowed rapidly away from the borehole. The maximum lateral extent of sand-filled vertical fracture wings was generally short. Nine boreholes had sand-filled fracture wings with a maximum length of 30 ft or less, three boreholes had fracture wings 70 to 100 ft in length, and only four (figs. 1, 2, and 3) had wings over 100 ft in length.

FIGURE 1. - Mine map, boreholes TW-3 and TW-4, with fracture orientations. (Modified from Lambert [15])

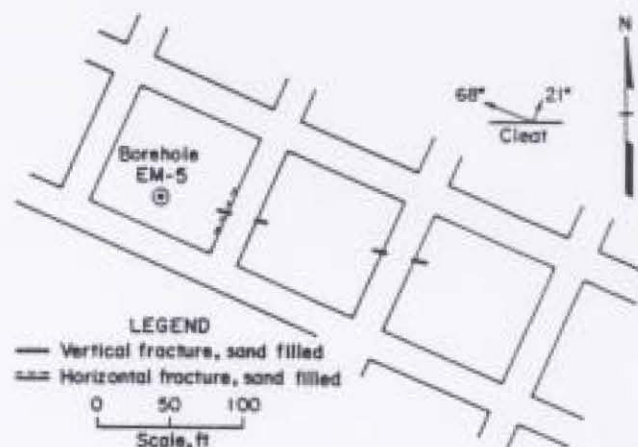
FIGURE 2. - Mine map, borehole EM-5, with fracture orientations. (Modified from Lambert [9])

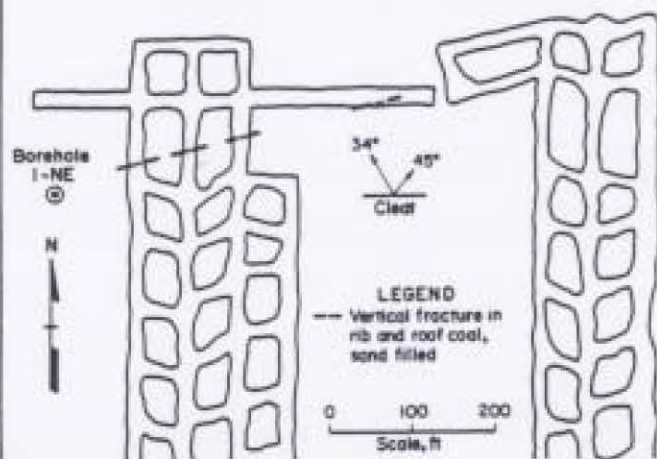
Most of the observed sand-filled and paint-coated vertical fractures penetrated or paralleled face cleat and occasionally butt cleat in the coalbed. It is interesting to note that the longest sand-filled vertical fracture (416 ft, borehole 1-NE, Illinois No. 6 coalbed, fig. 3) did not parallel a cleat direction, but was approximately 30° from the butt cleat orientation [8]. This may result from the influence of local horizontal stress fields or unobserved stair-stepping along face and butt cleat which gave an apparent orientation oblique to the cleat orientation. At several locations, fractures that paralleled the face cleat did not directly intercept the borehole if extended back from their point of observation. Apparently these treatment fluids followed a "stair-step" pathway through the coalbed, with only the face cleat fractures being observed on the exposed ribs and pillars.

It has been suggested [9,20,21] that gelled water stimulation treatments with sand proppant would theoretically produce relatively short, wide, sand-filled vertical fractures and foam treatments would produce longer, narrow, sand-filled fractures. Only four of the treatments observed underground used gelled water as the treatment fluid, and therefore a definitive statement relating the relative differences between the character of fractures resulting from the different fluids is not possible. However, the widest sand-filled fracture observed (4-1/2 in, borehole TW-2, fig. 8) was from a gelled water treatment in the Blue Creek Coalbed [14]. A 2-1/2-in-wide sand-filled fracture was also observed for the gelled water treatment on borehole USBM-4 in the Pittsburgh Coalbed [8], but a 2-1/2-in-wide sand-filled fracture was also observed for the foam treatment on borehole EM-6 in the Pittsburgh Coalbed [9,10]. The longest sand-filled vertical fracture observed (416 ft, borehole 1-NE) was also from a gelled water treatment in the Illinois No. 6 Coalbed (fig. 3) [8], where short fractures might be expected.

FIGURE 3. - Mine map, borehole 1-NE, with fracture orientations. (Modified from Elder [8])

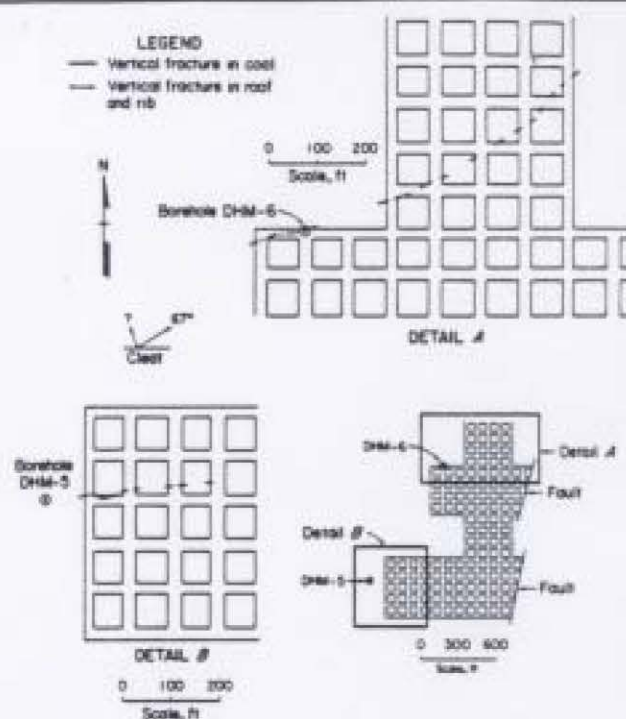
A good example of the additional traceable fracture length was observed at borehole DHM-6 (fig. 4) in the Blue Creek Coalbed, where sand-filled fractures could be traced a maximum of 95 ft (southwest) compared to paint-coated cleat observed 630 ft (northeast) from the borehole [17]. The paint-coated cleat at 630 ft are the longest observed evidence of stimulation fluid movement reported to date and was associated with one of the largest volume treatments. The most extensive paint-coated paths of fluid movement were observed in the vicinity of boreholes RP-2 and RP-3 in the Upper Freeport Coalbed (fig. 5) [19], and borehole TW-5 in the Blue Creek Coalbed (fig. 6) [9,16]. Fluid volume appeared to have some influence on the extent of fluid movement in that a greater number of fractures were associated with borehole RP-3, which had approximately a one-third larger volume treatment than RP-2. Borehole TW-5 also had one of the largest volume treatments.

FIGURE 4. - Mine map, boreholes DHM-5 and DHM-6, with fracture orientations. (Modified from Boyer [17])

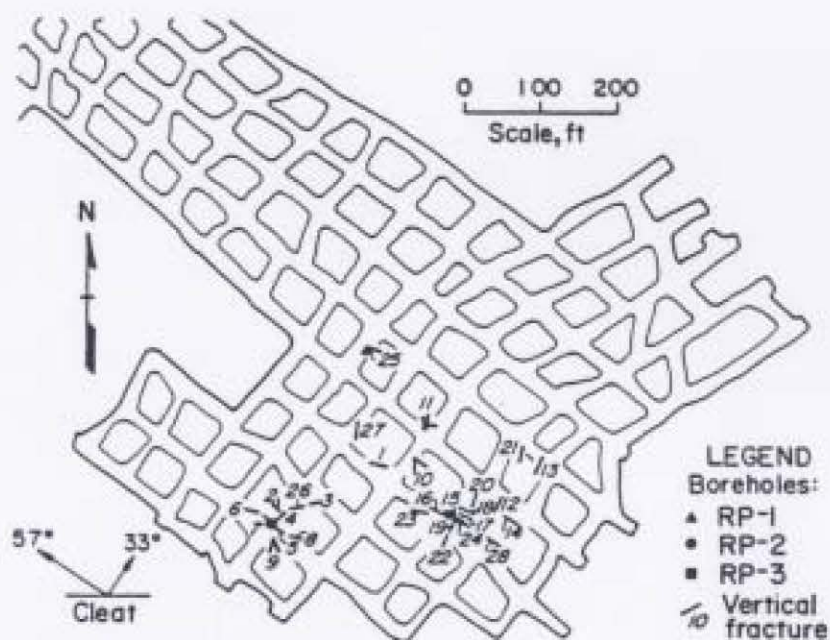
FIGURE 5. - Mine map, boreholes RP-1 through RP-3, with fracture orientations [19].

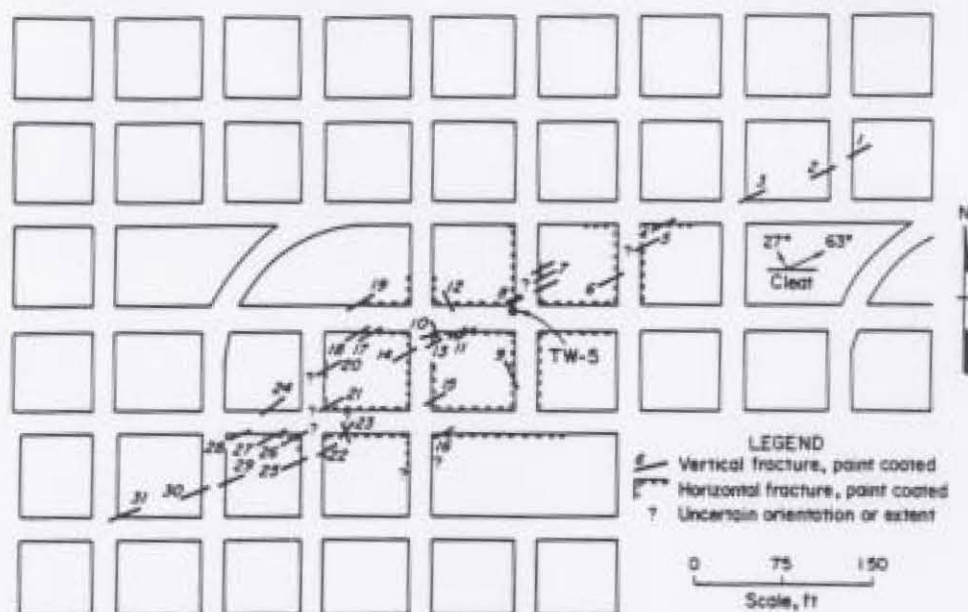
The most common location for the horizontal fractures is at the top of the coalbed at the interface with the roof rock. Horizontal fractures are also found along other distinct interfaces such as shale partings, shaley or hard, dense bands in the coalbed, or at the bottom or top of rider coals in the immediate roof rock. The distribution of sand or paint on horizontal surfaces was generally erratic (partially because of the difficulty in mapping their entire area), but in two cases (boreholes RP-2 and RP-3) there was some suggestion that there was a correlation between cleat orientation and the axis of horizontal lobes of paint (figs. 9, 10) [19]. At borehole TW-5 [9,16] the horizontal (and vertical) fractures covered an area with a general elliptical shape with the long axis parallel to the face cleat orientation (fig. 6).

FIGURE 6. - Mine map, borehole TW-5, with fracture orientations. (Modified from Mahoney [16])

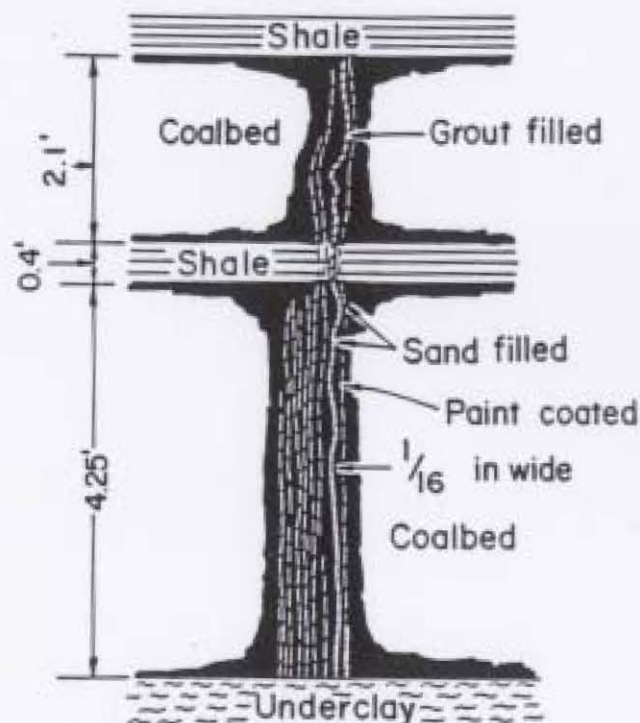
Zones of multiple parallel sand-filled and/or paint-coated fractures are common near the boreholes. The use of paint was a significant aid in identifying multiple fluid pathways that were essentially only the width of a cleat (fig. 7). At increasing distances from the boreholes the number of multiple vertical fractures usually decreases and only a single fracture remains. Multiple fractures were somewhat more prevalent in the friable coalbeds like the Upper Freeport (fig. 7) and the Blue Creek (fig. 8). Blocky coalbeds like the Pittsburgh tended to have a predominance of single, wider, sand-filled fractures. These observations may be somewhat biased, however, since none of the treatments in the Pittsburgh Coalbed contained paint, and many of the zones of multiple fractures in the friable coalbeds were identifiable only as paint-coated cleat. This points out the need for caution when comparing observations from treatments with and without paint.

Freeport Coalbed (boreholes RP-1, 2, and 3) had a distinct shale parting near the top of the coalbed. In some cases the parting acted as a barrier to the upward growth of fractures, as seen with most of the paint coated fractures shown in figure 7. But it was more common for the shale parting to be penetrated by the vertical fractures, which then became horizontal at the interface at the top of the parting and base of the upper coal bench (fig. 13). A distinct "shaley" band in the Pittsburgh Coalbed at borehole EM-8 was generally penetrated by the vertical fractures which continued vertical above it (fig. 14), but in one instance the fracture became horizontal above the band (fig. 15). It was also common to see small horizontal offsets in the vertical propagation of the fractures as different layers or bedding planes in the coalbed were encountered (fig. 14). These offsets occasionally resulted in an inclined or sinuous appearance to the "vertical" fracture. While the physical properties of the coalbed seemed to have some influence on the character of the fractures, that influence was variable and could not be considered predictable.

FIGURE 7. - Cross section of fractures at location 25 on the southeast rib near borehole RP-1. (Modified from Murrie [19])

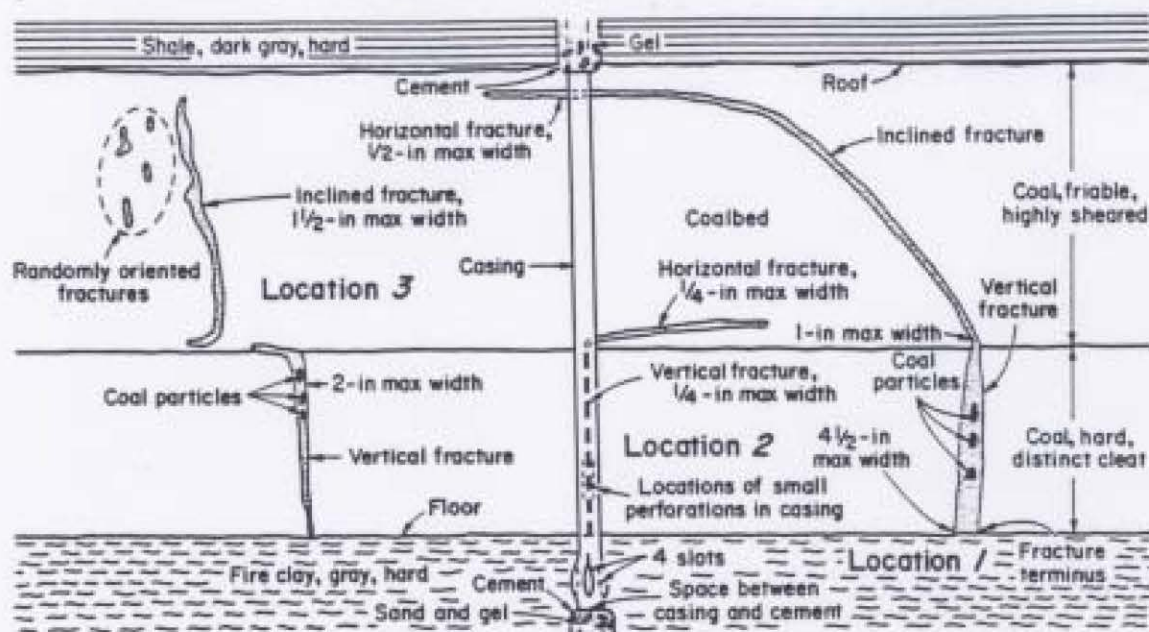
The physical properties of the coalbed seemed to have some influence on the propagation of fractures. Many of the vertical fractures in the Blue Creek Coalbed were present only in the more friable upper part. The vertical sand-filled fractures at borehole TW-2 were located in the bottom "hard" part of the Blue Creek Coalbed and inclined and became horizontal at or near the interface between the lower "hard" part and the upper "soft" friable part (fig. 8). The Upper

FIGURE 8. - Cross section of coal face at borehole TW-2 with fracture orientations. (Modified from Lambert [14])

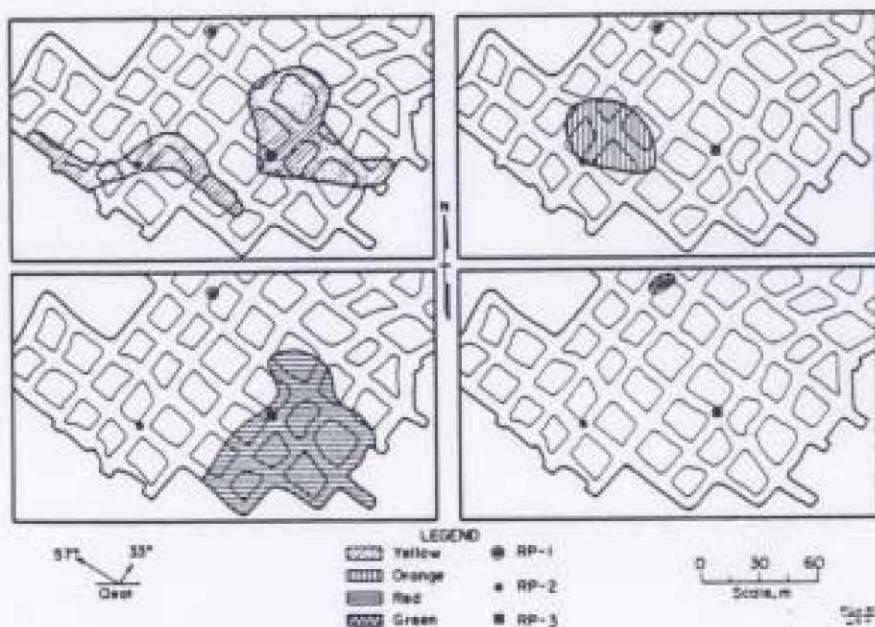
Multiple horizontal fractures on different planes have been observed in several cases. The sand-filled horizontal fractures are generally thickest near the wellbore (maximum of 1 in), usually are thin (less than 1/2 in) but quite variable in thickness along short lateral distances, and may be discontinuous along an exposed rib (fig. 11). The maximum lateral extents for sand-filled horizontal fractures were 250 ft in the Jawbone Coalbed (borehole DG-1A) [9] and 200 ft in the Upper Freeport Coalbed (borehole RP-3, fig. 10) [19]. The maximum lateral extents for paint-coated horizontal fractures were 265 ft and 200 ft in the Upper Freeport Coalbed (boreholes RP-2 and 3, figs. 9 and 10) [19] and 230 ft in the Blue Creek Coalbed (borehole TW-5, fig. 6) [9,16].

FIGURE 9. - Mine map, boreholes RP-1 through RP-3, with horizontal distribution of paint on roof [19].

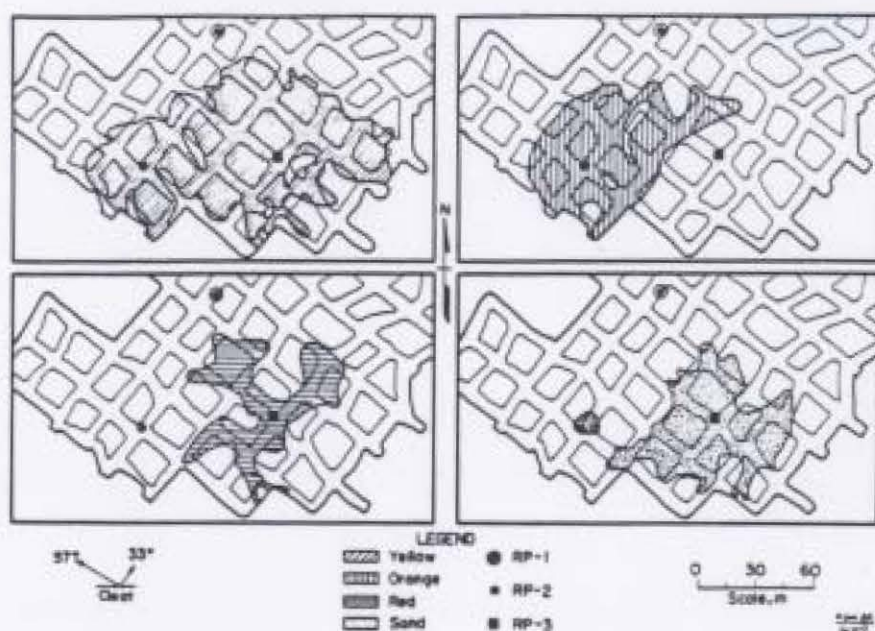
FIGURE 10. - Mine map, boreholes RP-1 through RP-3, with horizontal distribution of paint and sand on top of shale parting [19].

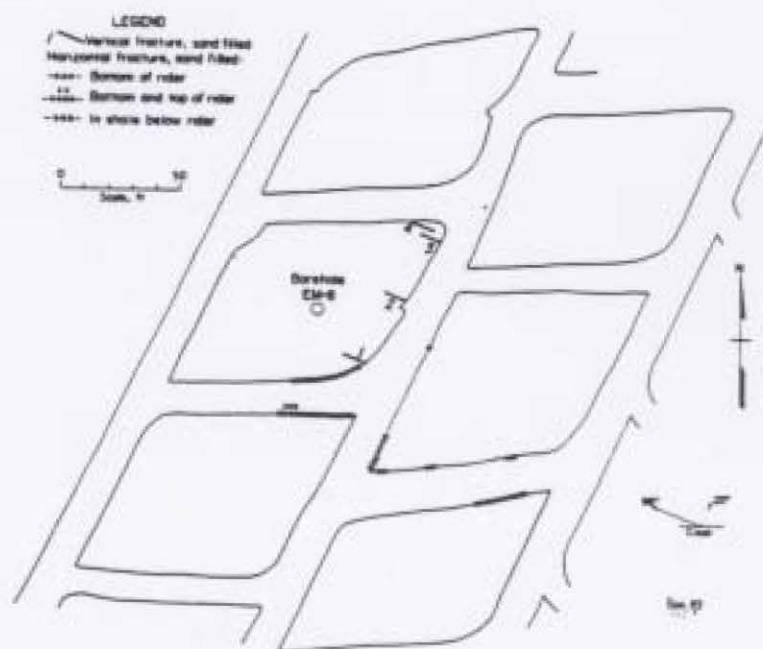
FIGURE 11. - Mine map, borehole EM-8, with fracture orientations.

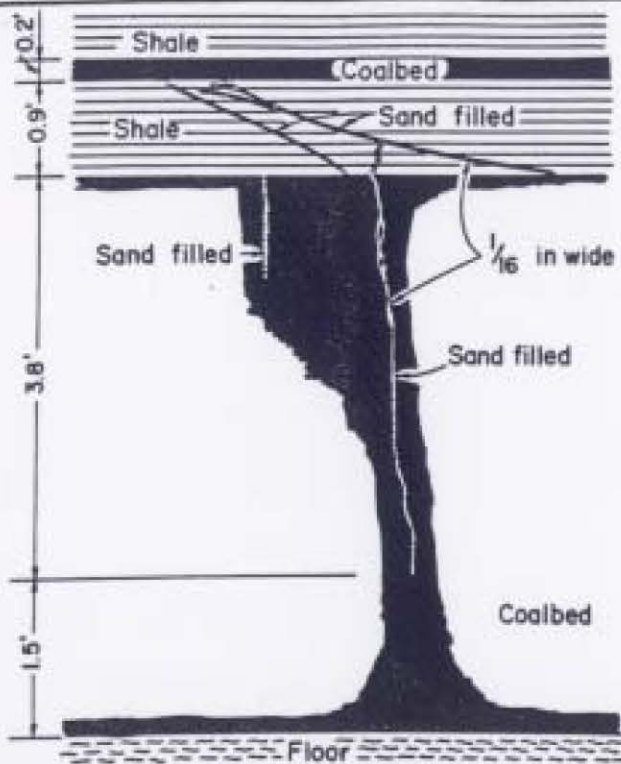
In several cases, the strata penetrated above coalbeds have been weak, thin shales below rider coals, and the fractures have been contained in strata that were generally mined along with the main bench of coal throughout the mine to prevent them from deteriorating and falling at a later time (fig. 12). Such strata penetrations should not really be considered "roof" penetrations; however, they are included as such in table 2.

FIGURE 12. - Cross section of fractures on rib at location 1 near borehole EM-8.

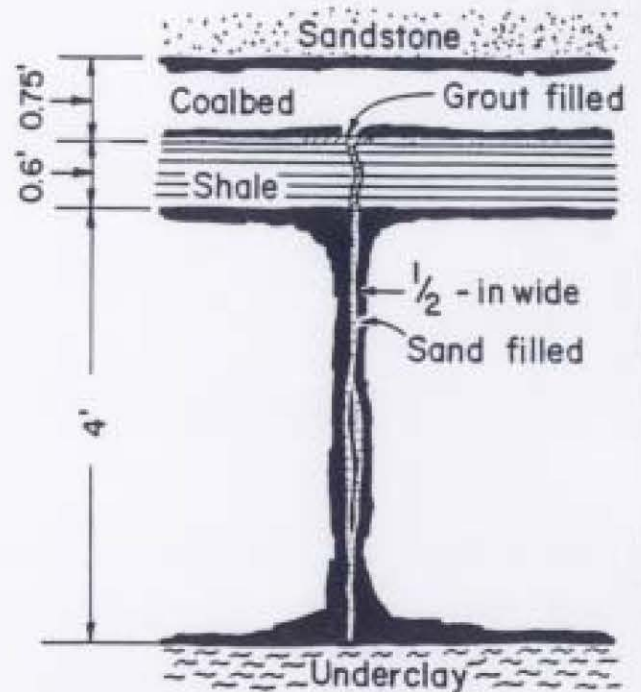
FIGURE 13. - Cross section of fractures at location 7 near borehole PR-2. [19]

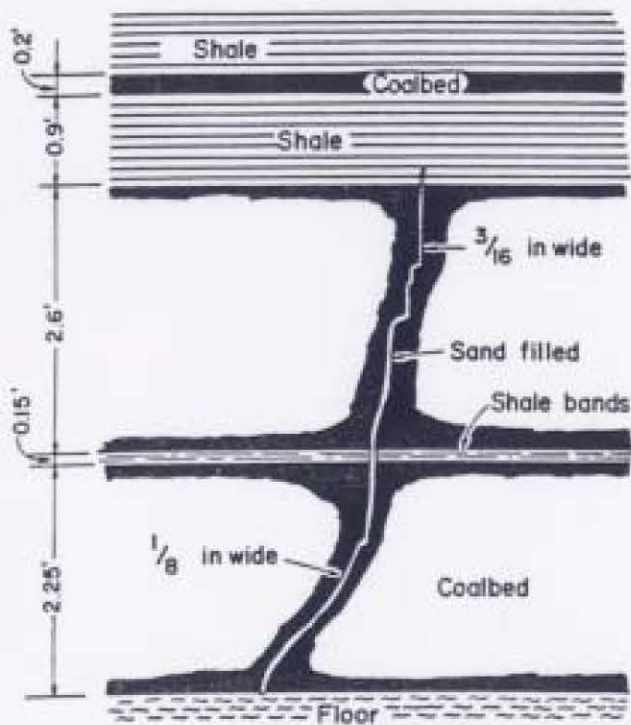
FIGURE 14. - Cross section of fracture on rib at location 4 near borehole EM-8.

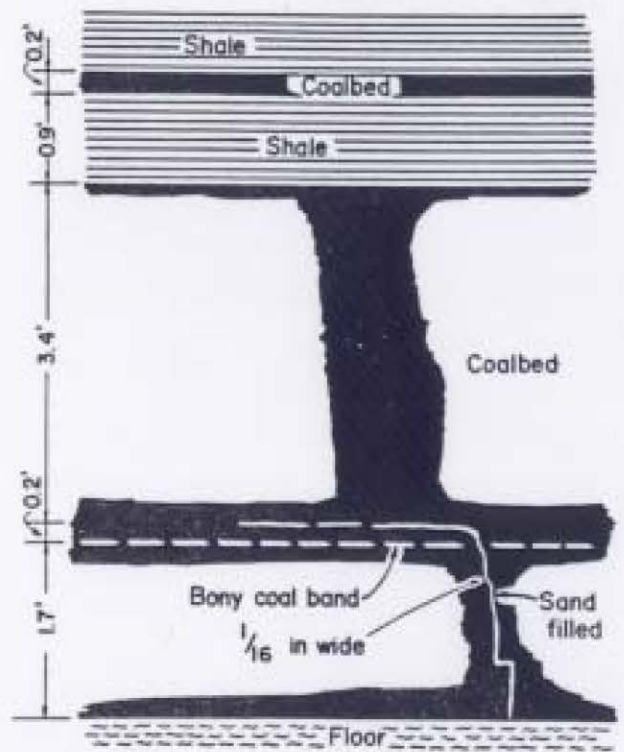
FIGURE 15. - Cross section of fracture on rib at location 2 near borehole EM-8.
